# **In-Plane Cyclic Straw Bale Shear Wall Testing**

**California Polytechnic University,  
San Luis Obispo**

Senior Project: Spring 2004

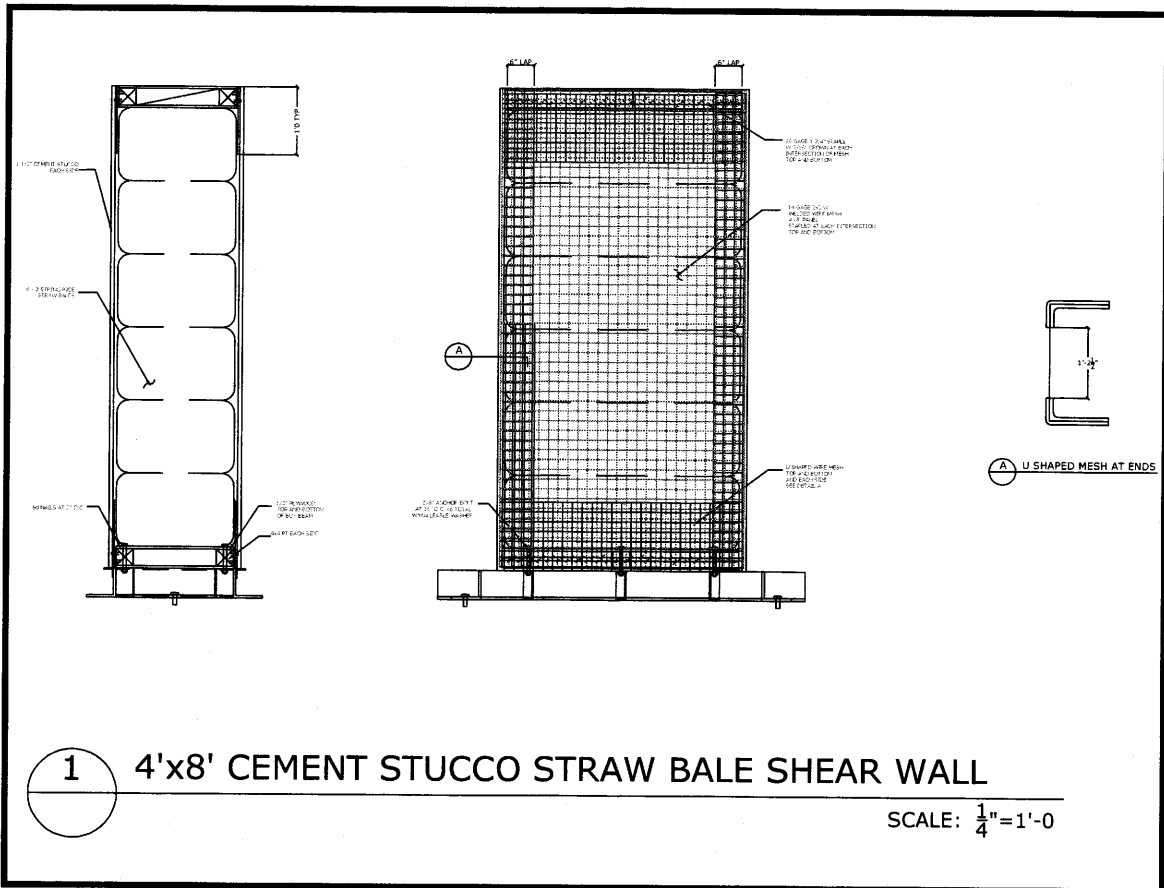
Figure 3.1-Wall Specimen Construction Detail

This wall specimen consisted of six 15"x 24"x 48" (height, depth, width) three string rice straw bales. The bales were stacked vertically to create a wall with a nominal height of 7'-6" from the bottom to the top of the bales, a nominal width of 4 feet and a nominal depth of 2 feet. We used a "medium" reinforcement detail of lapped wire mesh, as described by the report presented by the Eco-Build Network in previous tests. The wire mesh was manufactured in 14 gage 2" x 2" right angle squares and was overlapped 1'-0" at the top, bottom, and around the sides of the bales. The skin of the wall was a cement-stucco applied in three different coats. Figure 3.1 details the construction of the wall specimen.

The assembly of the wall began with the construction of sill and header box beams. These box beams consisted of two- 4 feet long pieces of 4 x 4 pressure treated lumber and two- pieces of 2 foot by 4 foot, 1/2 inch thick CDX plywood. A center strut of 4 x 4 pressure treated lumber was provided at the center of the box beam to resist buckling of the plywood. The box beams were nailed with 8d nails at 4 inches on center. Details of the box beam can be seen in Figure 3.1.

boundary mesh was secured, panel mesh on the faces of the bales were overlapped and secured to the box beam as previously described. Thin, non-structural, wire was tied from the wire mesh on one of the walls faces, through the straw bales, and tied to the wire mesh on the opposite face. These ties were used for the purpose of pulling the wire mesh to the face of the bales to avoid gaps that would cause varying skin thicknesses. Detailing of the wire mesh can be seen in Figure 3.1.

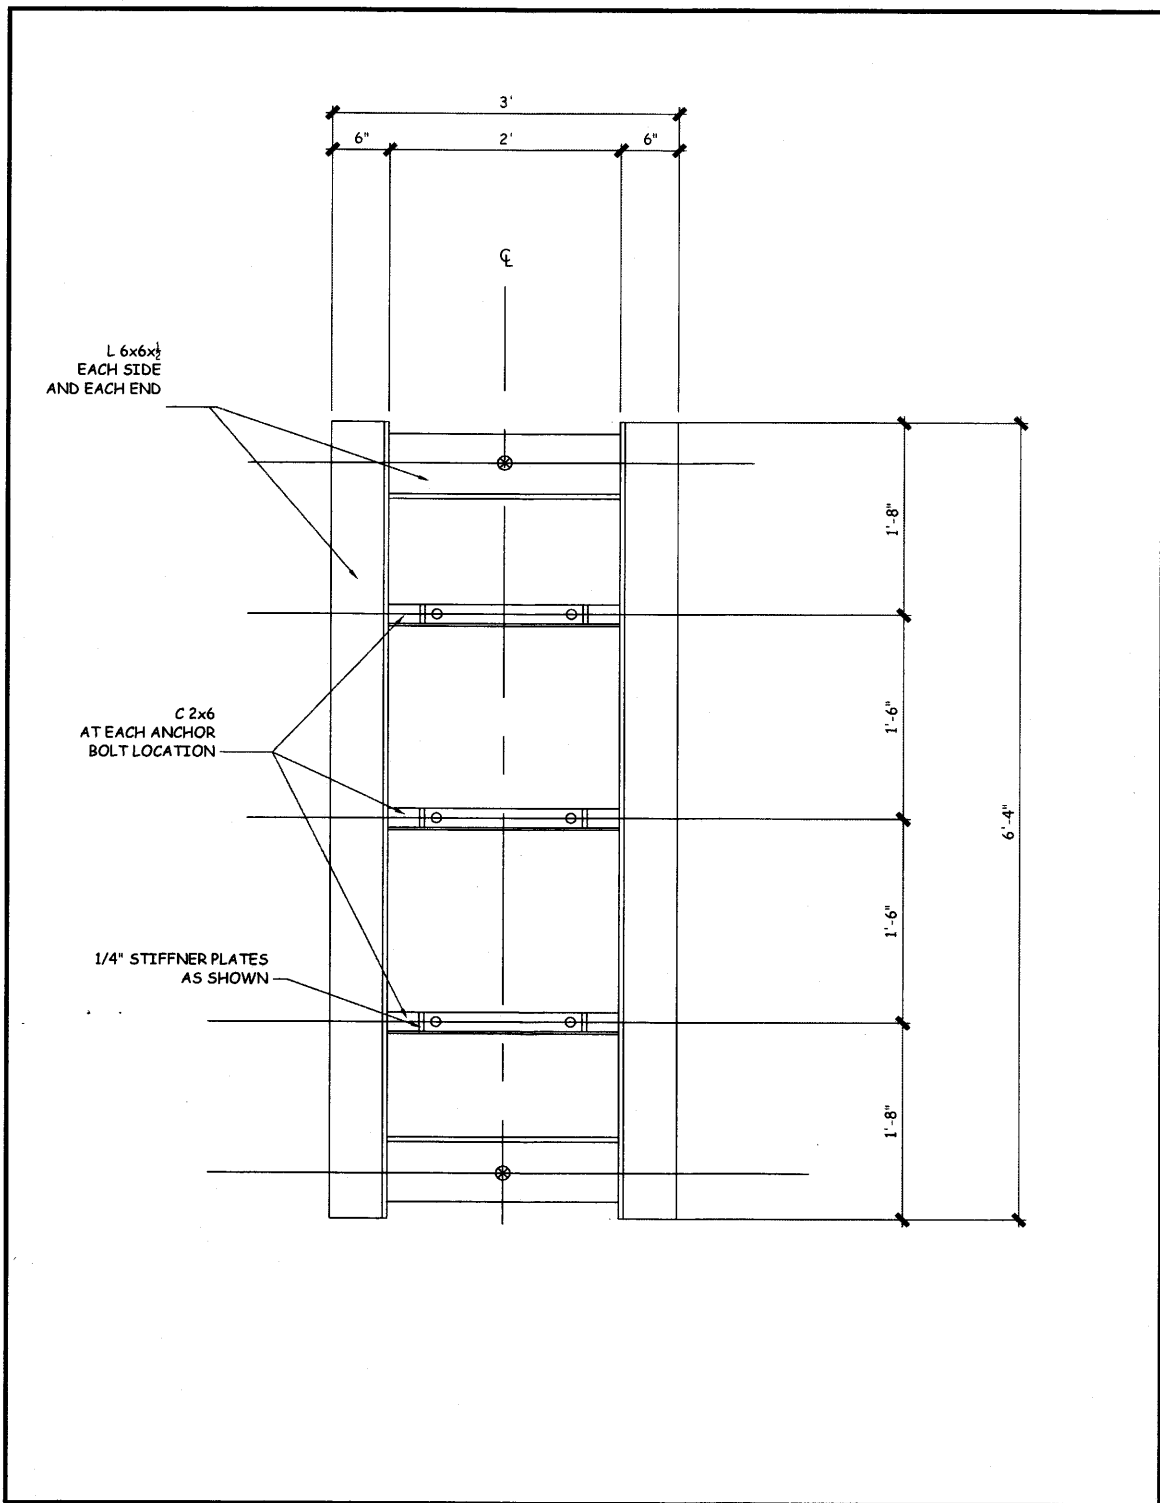
Figure 3.2 Base Detail - Plan View

The resources provided to us by the Architectural Engineering department of Cal Poly San Luis Obispo controlled the determination of a method of anchoring the wall to the High Bay laboratories strong floor. The construction of the wall specimen began with the detailing of a steel base to serve as a foundation which was then anchored to the High Bay strong floor. It is important to provide bearing for the cement stucco skin, and hence the steel base included a 2"x2"x1/4" angle oriented so that one of the 2 inch legs provided the required bearing surface. The base details are shown in Figures 3.2, 3.3, and 3.4.

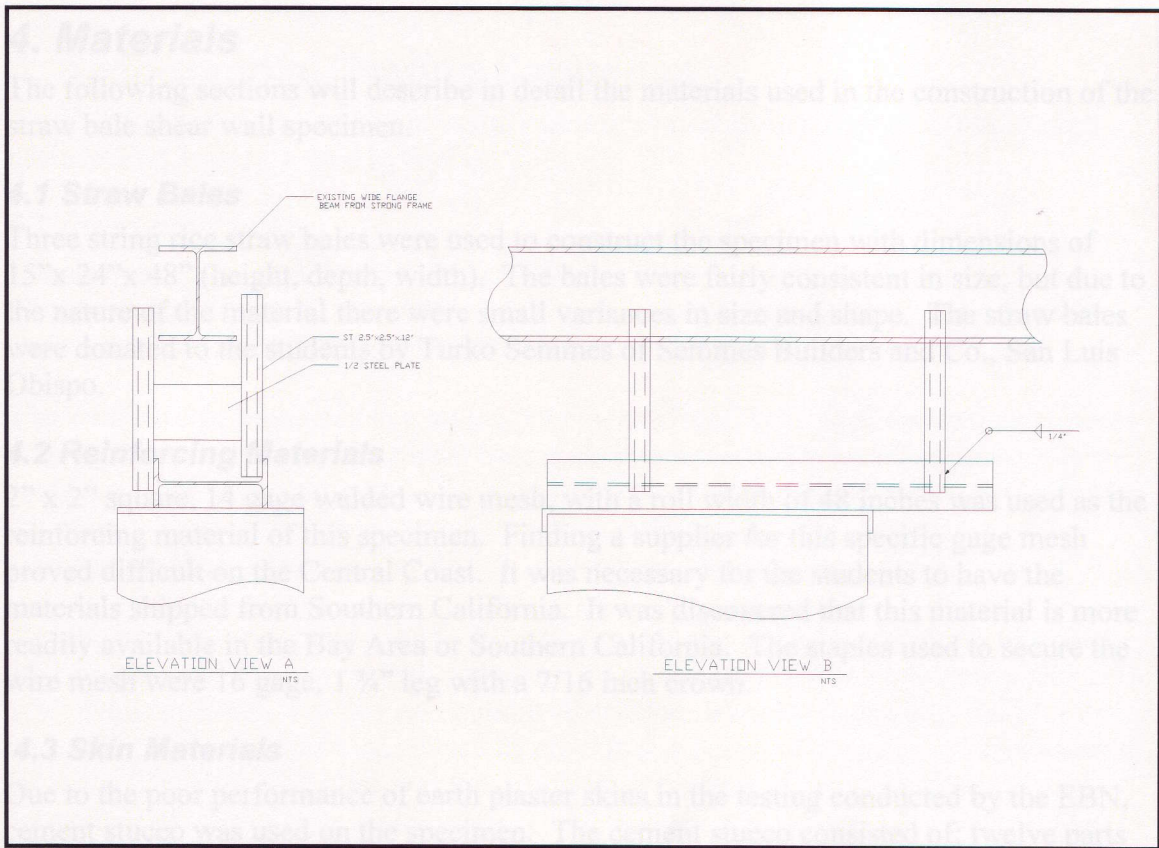
**Figure 3.5- Out of Plane Bracing Detail**

Lateral bracing was also constructed in order to prevent and minimize the wall's out of plane displacement. The bracing was constructed of four pieces of tube steel (2 ½"x2 ½"), vertically welded to the I-beam that was lying horizontally on the wall (two pieces of tube steel were located at each end of the wall). The tube steel members were welded so that there would be a very small gap between them and a beam from the strong column frame that was directly over the wall specimen, already in place in the Hi-Bay lab. 8" x 8" plates were then welded to the tube steel to ensure that the tube steel would not yield out of plane. For further explanation please see Figure 3.5.

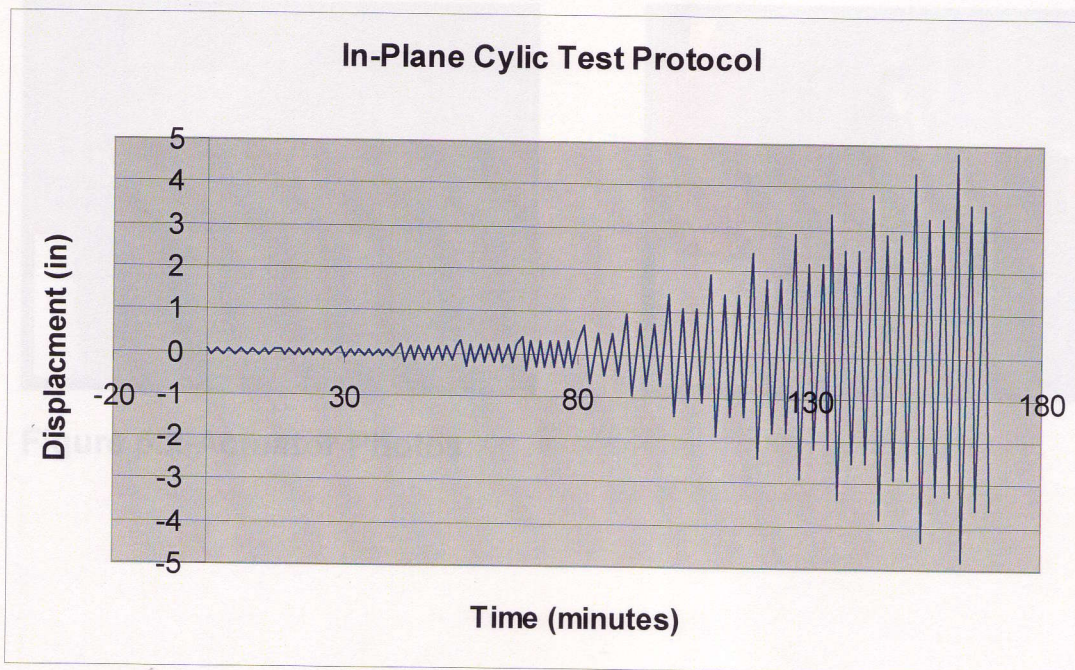
**Figure 5.1 –Cyclic Test Protocol**

The load protocol had sixteen steps, increasing in displacement, including trailing cycles to follow each peak cycle. The load steps are shown on the following page in Table 5.1.

The table and graph on the previous page represents the ideal testing protocol to be implemented. In Table 5.1 there are both peak displacements and trailing cycles. The peak displacements consist of maximum displacements for that particular load step, followed by a specific number of trailing cycles of smaller displacements. This type of loading was used to model cyclic loading and is also depicted in Figure 5.2. The peak displacements steadily increase until a maximum displacement for the specimen is reached. As described in section six, the peak displacements shown here were not reached for our specimen.

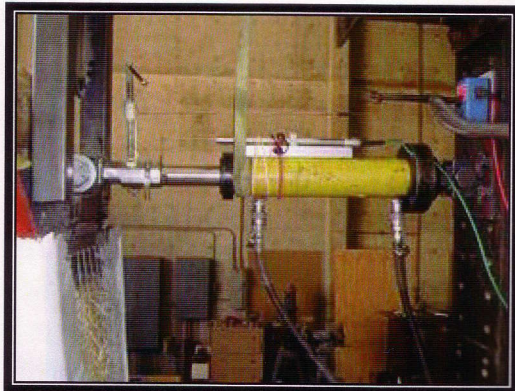
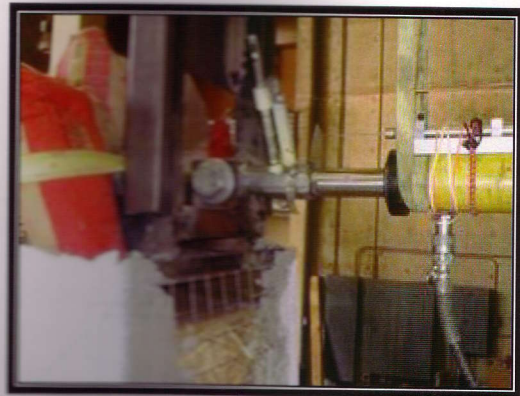
Figure 5.2-Actuator Photos

The actuator was connected to a strong column by a steel base plate and two steel plates with 1 ¼" diameter holes. The steel base plate was bolted flush with the strong column using 4 – 1 inch diameter bolts. The plates with holes were welded perpendicular to the base plate. This configuration was designed in order to allow for the rotation of the actuator arm during testing. For further explanation, see detail Figure 5.1.

The actuator was then connected to the wall specimen in a similar fashion to its strong wall connection. The connection consisted of a steel base plate and two steel plates with 1 ¼" diameter holes. For this particular wall specimen, a wide flange was used for the purpose of adding a dead load as well as providing a means of connecting the actuator to the wall. The steel base plate was welded flush to the web of the wide flange (for orientation of wide flange see Figure 5.1), and the steel plates with holes were welded perpendicular to the base plate. It was imperative that the actuator was placed to allow for the desired forward and backward stroke. For further explanation, see detail Figure 5.1.

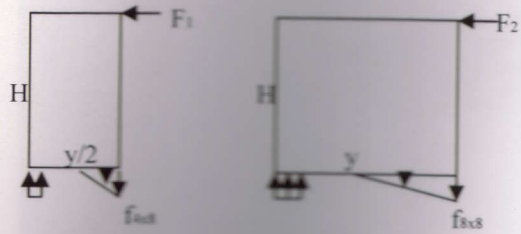
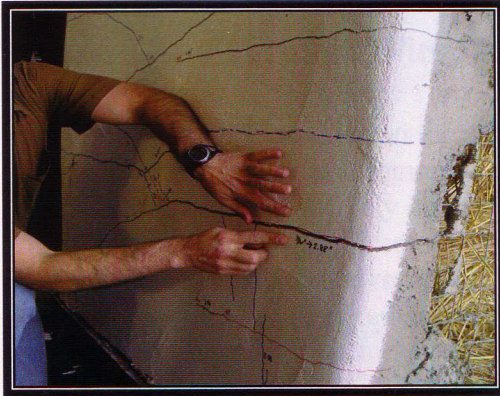
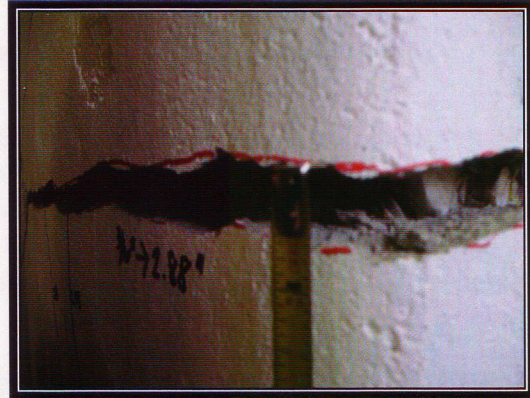
**Figure 6.2 – 1" Crack Photos**

The first signs of permanent damage occurred in the form of cracks at a displacement of .67". Cracks continued to form, eventually causing spawling on the rear left side at a displacement of 1.68" and a corresponding load of 6500lbs. It was expected that the cement stucco would act in compression and bear on the angles provided until cracks were large enough to engage the steel wire mesh. The largest opening of a crack was measured to be 1" on the right side of the specimen, and occurred above the one foot area where the bottom U-shaped wire mesh overlapped with the panel wire mesh. The 1" crack can be seen in Figure 6.2 below.

The location of cracks on the wall performed as expected. In previous testing, the major flexural cracks formed just above the cutoff of the overlapping layers of wire mesh. This phenomenon was also observed on the 4 x 8 specimen. These behaviors were similar due to the fact that both walls, the 8 x 8 and the 4 x 8, were governed by flexure. Cracking in these locations is desirable in comparison to cracks forming near the base of the wall which would result from a lack of the 1 foot overlap, and would decrease the specimen's bearing capacity.

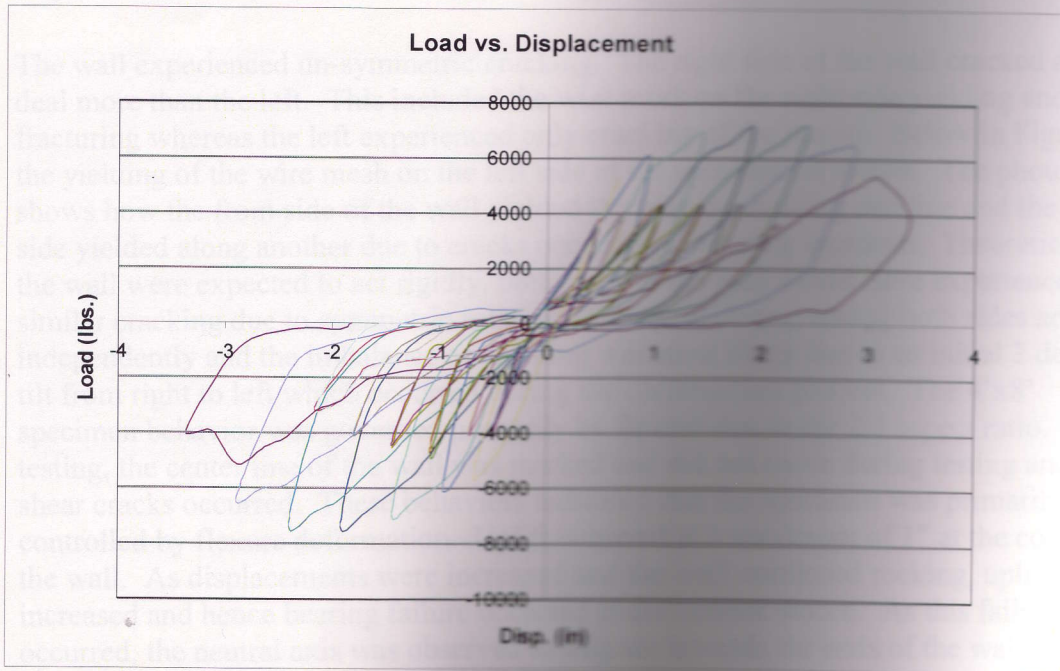
Figure 6.1 - Hysteresis Loop of Loads vs. Displacements

Based on the previous testing results a maximum load was estimated to occur at the maximum relative peak displacement of 4.8" required by the loading protocol. It was estimated that a load of about 4.75 kips would correlate to such a displacement, but a smaller load was expected as a result of our aspect ratio (See calculations on page 15). As can be seen in the hysteresis loop of Figure 6.1 the maximum load experienced by the specimen was 7000 lbs. (7 kips), with a corresponding displacement of 2.44". The maximum displacement the specimen reached was 4.32" with a corresponding load of 393.6lbs. It can be concluded that at displacements beyond 2.44", the compression block of the cement stucco had been greatly reduced as a result of spawling. This decreased the internal moment capacity of the specimen. The deformations imposed beyond 2.44"

resulted in continually decreasing loads due to the remaining capacity of the steel mesh and each vertical wire strands subsequent failure. This phenomenon, known as the zipper effect, began at a deformation of 3.38" with at a load of 3500 lbs. Although the zipper effect did not occur until 3.38" it is expected that the loads decreased after 2.44" due to plastic deformation of the steel.

The analysis of the data collected yielded a hysteresis loop that reflects the capabilities of a straw bale shear wall to dissipate energy effectively. The hysteresis loop of 8 x 8 walls is very similar to that of the 4 x 8 wall in shape and behavior with the only major difference being decreased capacity due to the decrease in aspect ratio.

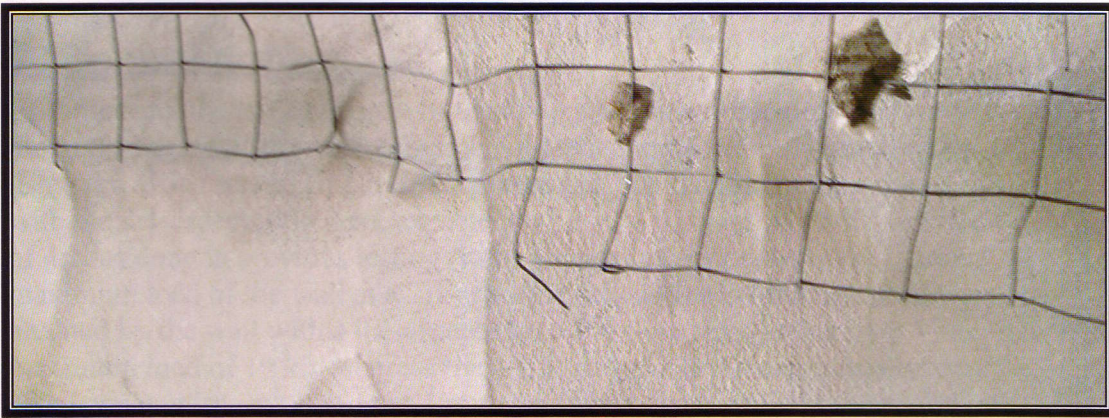
**Figure 6.3 – Fractured Wire Mesh from Right Side of Specimen**

The wall experienced un-symmetric cracking. The right side of the wall cracked a great deal more than the left. This included the wire mesh on the right side yielding and fracturing whereas the left experienced only cracking of the stucco. Below in Figure 6.3, the yielding of the wire mesh on the left side of the specimen is shown. The photo below shows how the front side of the wall yielded the wire mesh along one line and the back side yielded along another due to cracks occurring at varying locations. Theoretically if the wall were expected to act rigidly, both sides of the wall would have experienced similar cracking due to symmetric rotation. However, during testing both sides acted independently and the imbalance of cracking was most likely due to an initial 2 degree tilt from right to left which occurred during the construction process. The 4'x8' specimen behavior was governed primarily by flexure due to the 2:1 aspect ratio. Before testing, the center line of the wall was marked and did not move during testing and few shear cracks occurred. These behaviors indicated that the specimen was primarily controlled by flexure deformation. Uplift occurred at a maximum of 1" at the corners of the wall. As displacements were increased and the wall continued rocking, uplift increased and hence bearing failure occurred in the cement stucco. As this failure occurred, the neutral axis was observed to migrate towards the ends of the wall, slowly decreasing and thereby engaging the wire mesh more. Once the main crack spanned across the length of the specimen, the neutral axis began returning toward the center of the wall as the rocking action occurred primarily at the crack location instead of the base of the wall.

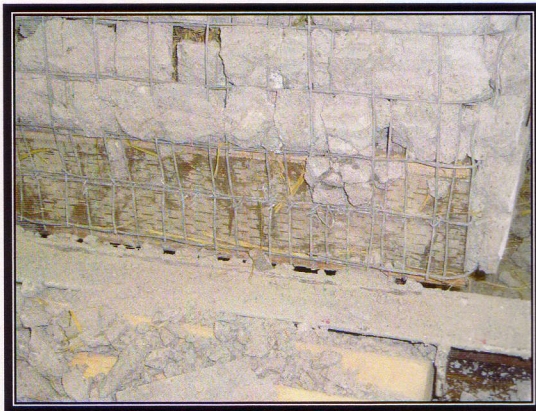
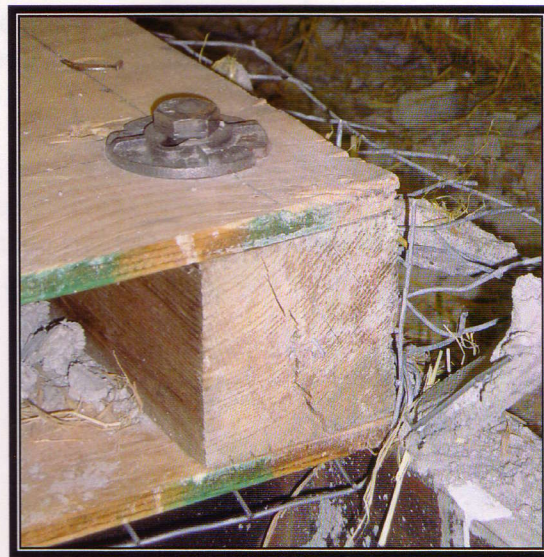
**Figure 6.4 Base Connection Post Testing**

The connection of wire mesh to the 4"x4" sill plates, nor the staples in the connection experienced any failure and remained intact. The 4"x4" sill plates cracked vertically down their centers, most likely due to uplift and the edge distance of anchor bolts on each end. The plywood remained connected to the 4"x4" sill plates with little sign of uplift. When the anchor bolts were removed from the box beam indentations from the washers could be seen as a result of uplift.
