# **Straw Bale Shear Wall Lateral Load Test**

California Polytechnic State University  
San Luis Obispo  
Architectural Engineering Dept.  
December, 2000

**By Jason Nichols  
& Stan Raap**

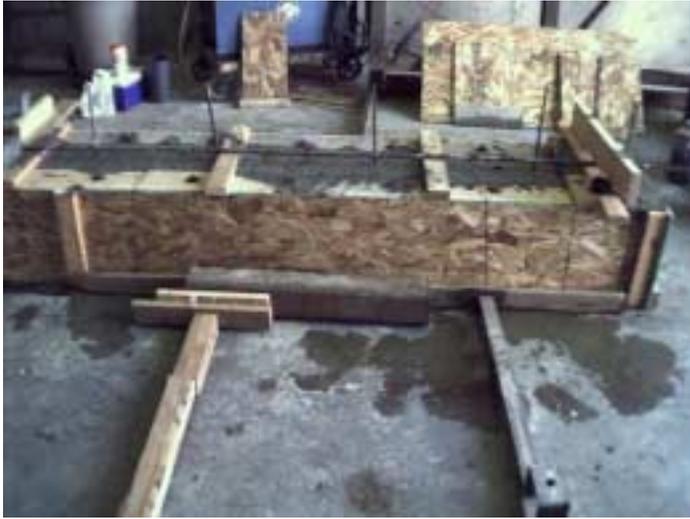
**Figure 2 – Side view of poured footing**

*Concrete Foundation Construction* - Three 1½"φ all-thread bolts were inserted into the threaded holes in the "strong floor" of the High Bay Lab in Building 21 at Cal Poly State University San Luis Obispo. A ¾" steel plate welded to a nut was screwed onto the first bolt to anchor the footing against uplift. Five holes were drilled in each of the 4x8 members for the anchor bolts. Formwork for the footing (24" wide x 12" tall x 10'-0") was constructed, and the 4x8 members were nailed at the top of the formwork on each side. Plastic was placed on the floor to allow for simple removal of the footing upon completion of the testing. The rebar cage was constructed and placed inside the formwork. The anchor bolts were then placed in the 4x8 sill plates. Four #4 rebar pins were tied with wire to the center of the rebar cage, extending 16" out of the top of the formwork, which would be used for attaching the straw bales to the footing. The concrete was poured, after which two Simpson "HD5A" holdowns were placed at the compression end and two Simpson "HD10A"s were placed at the tension end (see Figures 2 & 3). Four concrete cylinders were poured for testing at each 7-day interval. The footing reached its 28-day strength of 3289 psi on 11/14/2000 (14 days before the first test).

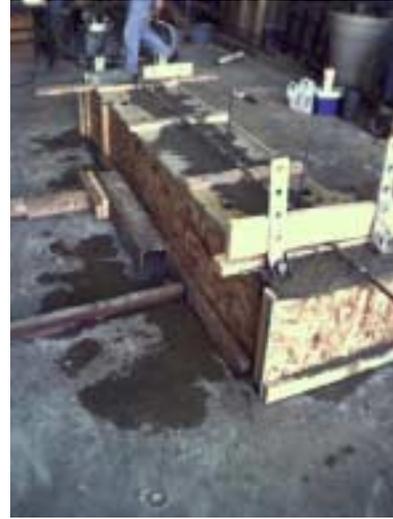
**Figure 3 – Front perspective**

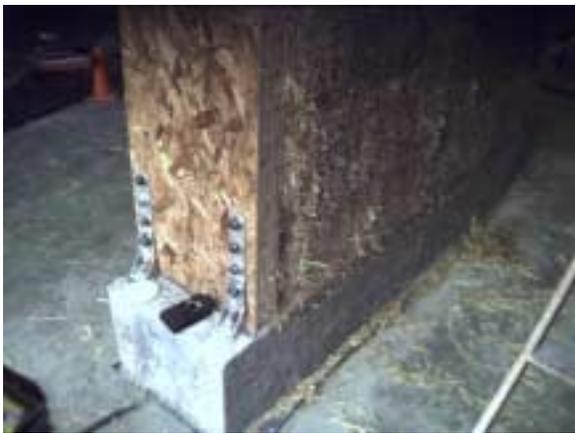
**Figure 4 – Front holdowns**

*Wall Assembly* - Two bales were inserted over the rebar pins and placed on the footing. A total of twelve 3-string rice straw bales (24"x16"x48"), six courses high, were used for the wall. Once the bales were stacked, they were allowed to settle for several days under their own weight.<sup>1</sup> The wall was measured at 7'-7" tall (from the top of the footing to the top of the bales) after settlement occurred, and the box beams were cut to match that height. The 7'-7" box beams were then bolted to the holdowns at each end (see Fig. 4), and the 10'-0" long box beam was placed

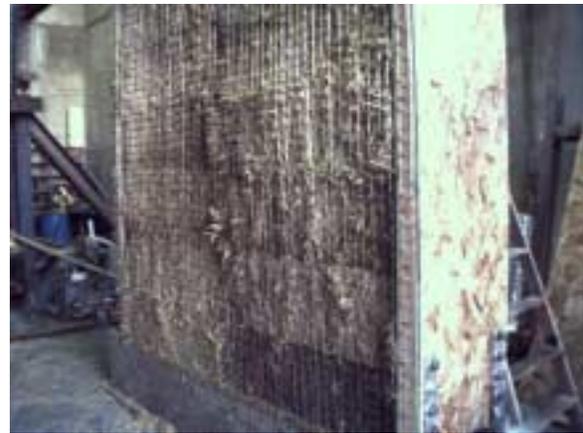
**Figure 5 – Mesh over bales**

on top of the wall (see Fig. 7). Simpson "1212L" strap ties were installed at each upper corner of the wall (4 total) to connect the top plate to the posts. 16-gauge galvanized welded wire 2"x2" mesh (Jaenson Wire Company™) was placed on each side of the wall in 28" wide vertical strips. Each strip of wire lath was overlapped 6" (3 squares) with the adjacent strips. Because a staple gun was not readily available, 8d nails at 6"oc were used to attach the lath to the wood members, hammering the nails in half-way and bending the nail over the lath to secure it to the member.<sup>2</sup> It was agreed that this would be adequate for testing purposes since the lag screws would provide the primary shear transfer from the boundary elements to the plaster skins. Using a bale needler (made from a 30" long bent piece of #3 rebar), 16-gauge wire was tied through each bale to the wire mesh at approximately 16"oc, vertically and horizontally, to tighten the lath against the surface of the bales for ease of plastering (see Figs. 5 & 6).

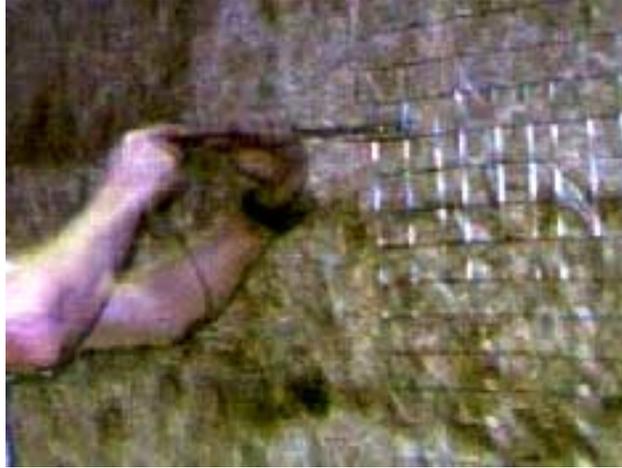
**Figure 6 – Needling wire through bales**

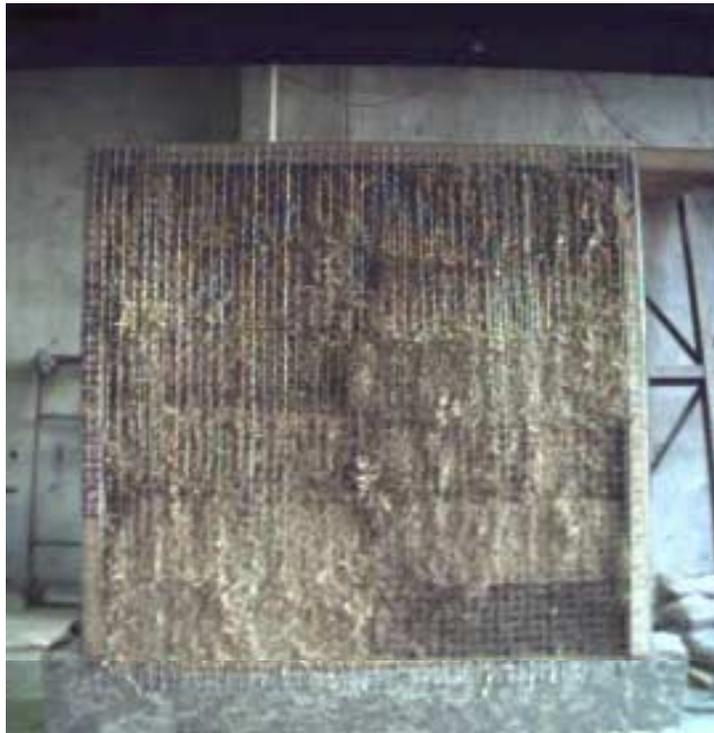
**Figure 7 – Unplastered wall elevation**

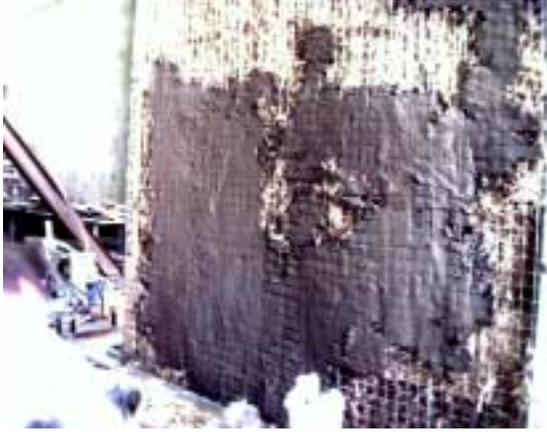
**Figure 8 – Partial scratch coat applied**

*Plastering* - The first coat of plaster was applied on November 8 *only* to the bales (see Fig. 8). However, for testing and construction purposes, it is recommended that the scratch coat also be applied over the boundary members in a bale structure or in future tests to ensure continuity

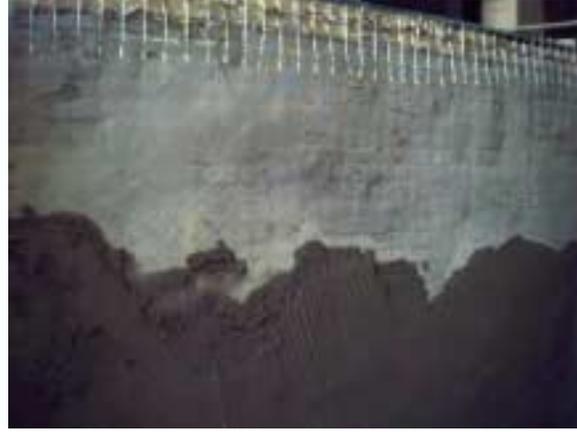
**Figure 9 – Partial brown coat applied**

between the plastered bales and the shear connection at the wood members. Since the goal of the test was to form diagonal tension cracks in the center of the plaster skins, an additional 6"-wide strip of wire mesh was attached at the boundary members before applying the second coat, as shown in Figure 9. It was believed that a second layer of reinforcement at the locations of shear transfer would prevent premature cracking of the plaster at an undesirable location during testing. The second coat was applied six days after the scratch coat (11/14), covering both the boundary members and the first layer of plaster. Three plaster cylinders were poured for the scratch coat, and two cylinders were poured for the second coat for testing at each 7-day interval and determination of the strength at the time of testing. It should also be noted that the cured scratch coat was not as rough as needed for standard construction purposes. Therefore, a wetter mix was used for the brown coat to provide sufficient adhesion between the two coats. As a result, the second coat had a significantly lower compressive strength than the scratch coat. After applying the second coat, the wall was covered with a plastic tarp to prevent the stucco from drying too quickly. After completion of the testing procedures, samples of the stucco were removed from the wall and measured for thickness. An average plaster thickness of  $1\frac{1}{8}$ " over the straw bales was calculated for the left side of the wall (if one were facing the wall from the loading mechanism), with an average of  $\frac{7}{8}$ " at the boundary members; and the right side of the wall was found to have an average thickness of  $1\frac{1}{4}$ " over the bales, with 1" of stucco at the boundary members.

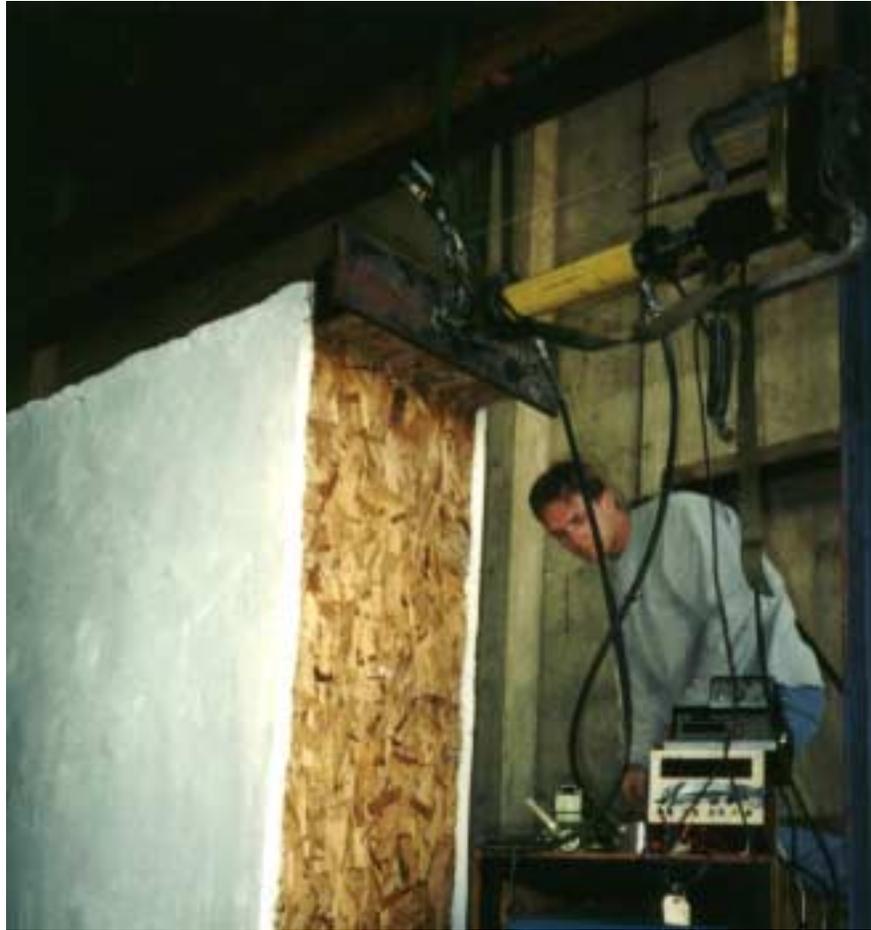
**Figure 10 – Wall loaded during first test**

A  $\frac{5}{4}$ " steel plate, with two  $\frac{1}{8}$ " steel plates welded to its ends, was attached to the top box beam with six  $\frac{5}{16}$ " lag screws (3 each side). Two small pieces of L2x2x $\frac{1}{8}$ ", with 1" holes drilled in them, were welded to the center of the steel plate for attachment of the loading mechanism. The base of the load cell was bolted to the flange of the steel column, and the loading end of the ram was bolted to the angles welded to the steel plate. As a safety measure, the loading mechanism was also strapped to the overhead frame to keep the device from falling in case of failure at the connections to the wall or steel column, which happened to occur at the end of the first test. The deflection was measured at the top of the wall. The load cell and deflection apparatus were connected to their respective gages, one reading the load applied to the nearest ten pounds and the other reading the deflection to the nearest  $\frac{1}{100}$  of an inch. A hydraulic jack was also connected to the ram for applying pressure to the wall (see Fig 10).

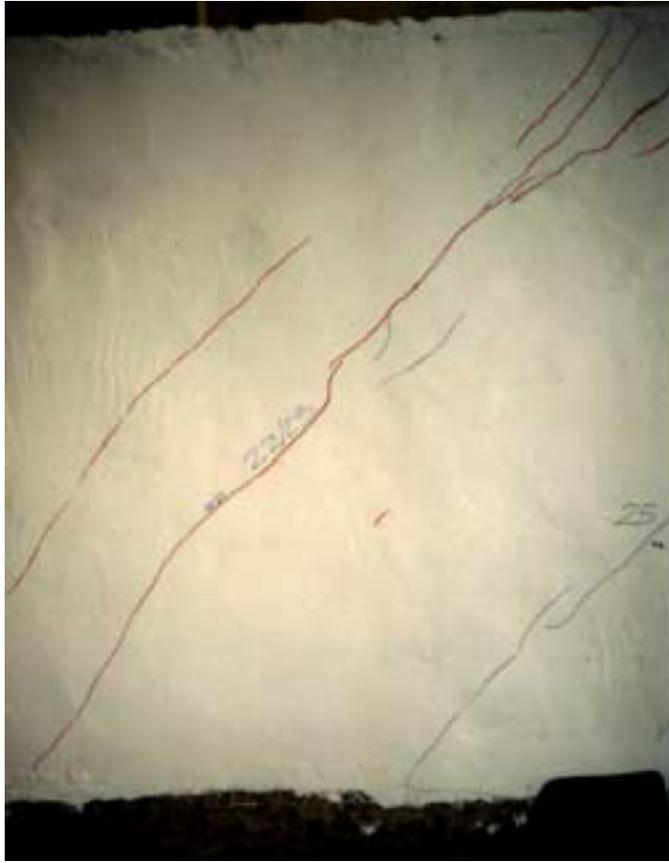
**Figure 11 – Cracked left face after tests 1 & 2**

The first noticeable crack in the stucco occurred on the left face at 21,450 pounds. No significant drop in the load was observed. Significant cracks in the plaster over the bales were also observed at 25,548 pounds, and at the plaster over the boundary elements around 26,000 pounds (see Fig. 11). The test was halted when two bolts at the connection of the load cell to the steel frame sheared, and the load cell separated from the wall at 26,480 pounds, with a total wall deflection of 3.03". The connection failure was determined to be a result of the column flange displacing since the load cell was not concentrically connected to the column (the device was not centered on the column in order to ensure that the load was applied directly perpendicular to the wall and thereby preventing torsion in the wall). See the results on the next page.

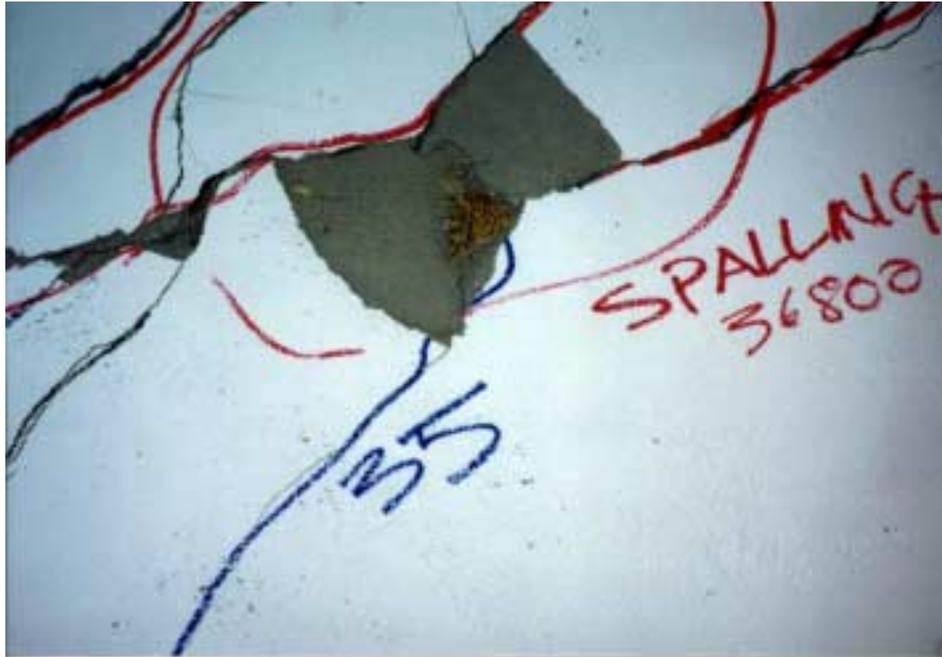
Figure 14 – Spalling on left face

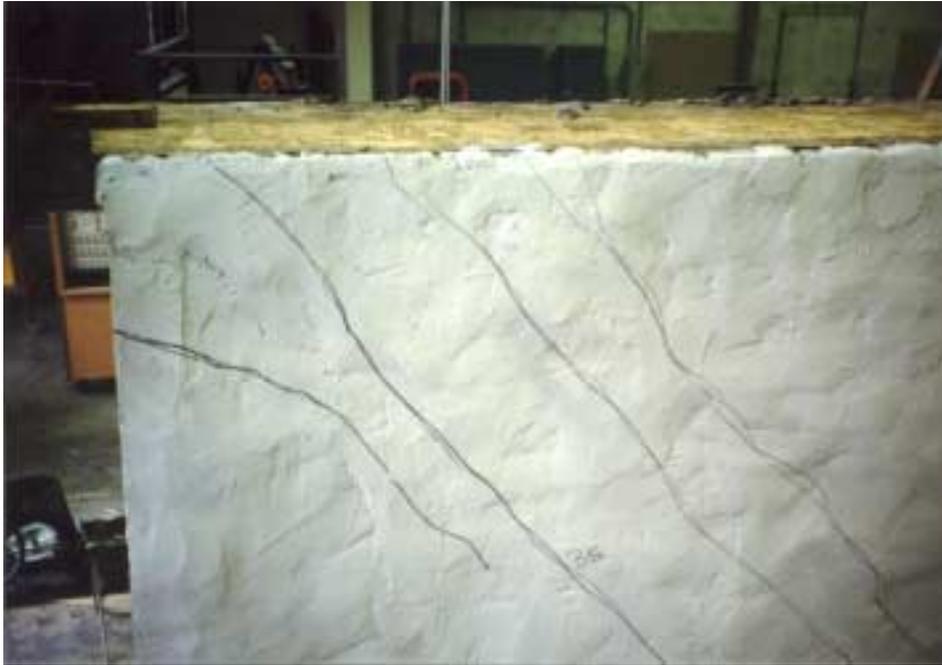
**Figure 15a – Right face cracks during final test**

The final test was conducted on December 7. A 60,000-pound capacity loading device was installed for the third test (Fig. 12). The wall was loaded in a similar manner as the first two tests. Additional large cracks began to form in the wall at 28,000 pounds. The plaster skin on the right face began to show cracks at 31,370 pounds, at which there occurred a slight drop in the load. Shortly after the cracks formed in the right face, the wire lath on the left side began to break in tension at the center of the wall (Fig. 13) and spalling of the plaster occurred near the upper-front corner of the wall just before ultimate failure (Fig. 14). The spalling was attributed to the scratch coat being too smooth upon curing, and therefore can most likely be prevented by using the proper tool to scratch the wet surface. Finally, at 36,840 pounds ultimate failure of the plaster skins occurred and the wall stopped taking any further load.

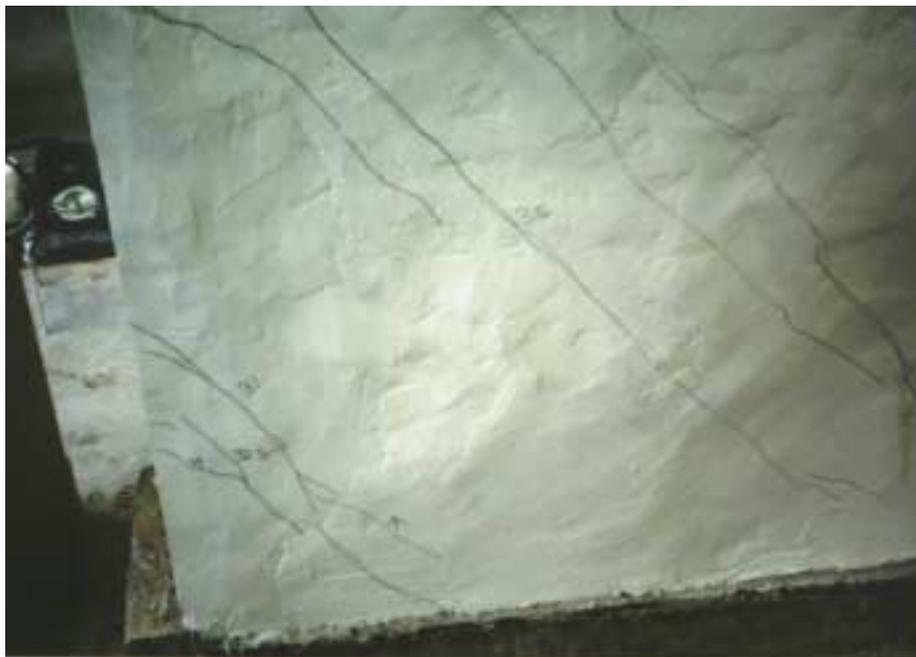
**Figure 15b – Outer shear cracks in right face**
